*Shijiazhuang CAPT Full Standard
Range of Steel TB Taper
Bushings – A **New** Choice
for Industrial Safety!*

SHIJIAZHUANG CAPT POWER TRANSMISSION CO., LTD

C45 Steel High-Strength TB Taper Bushings – Your Safe Choice!

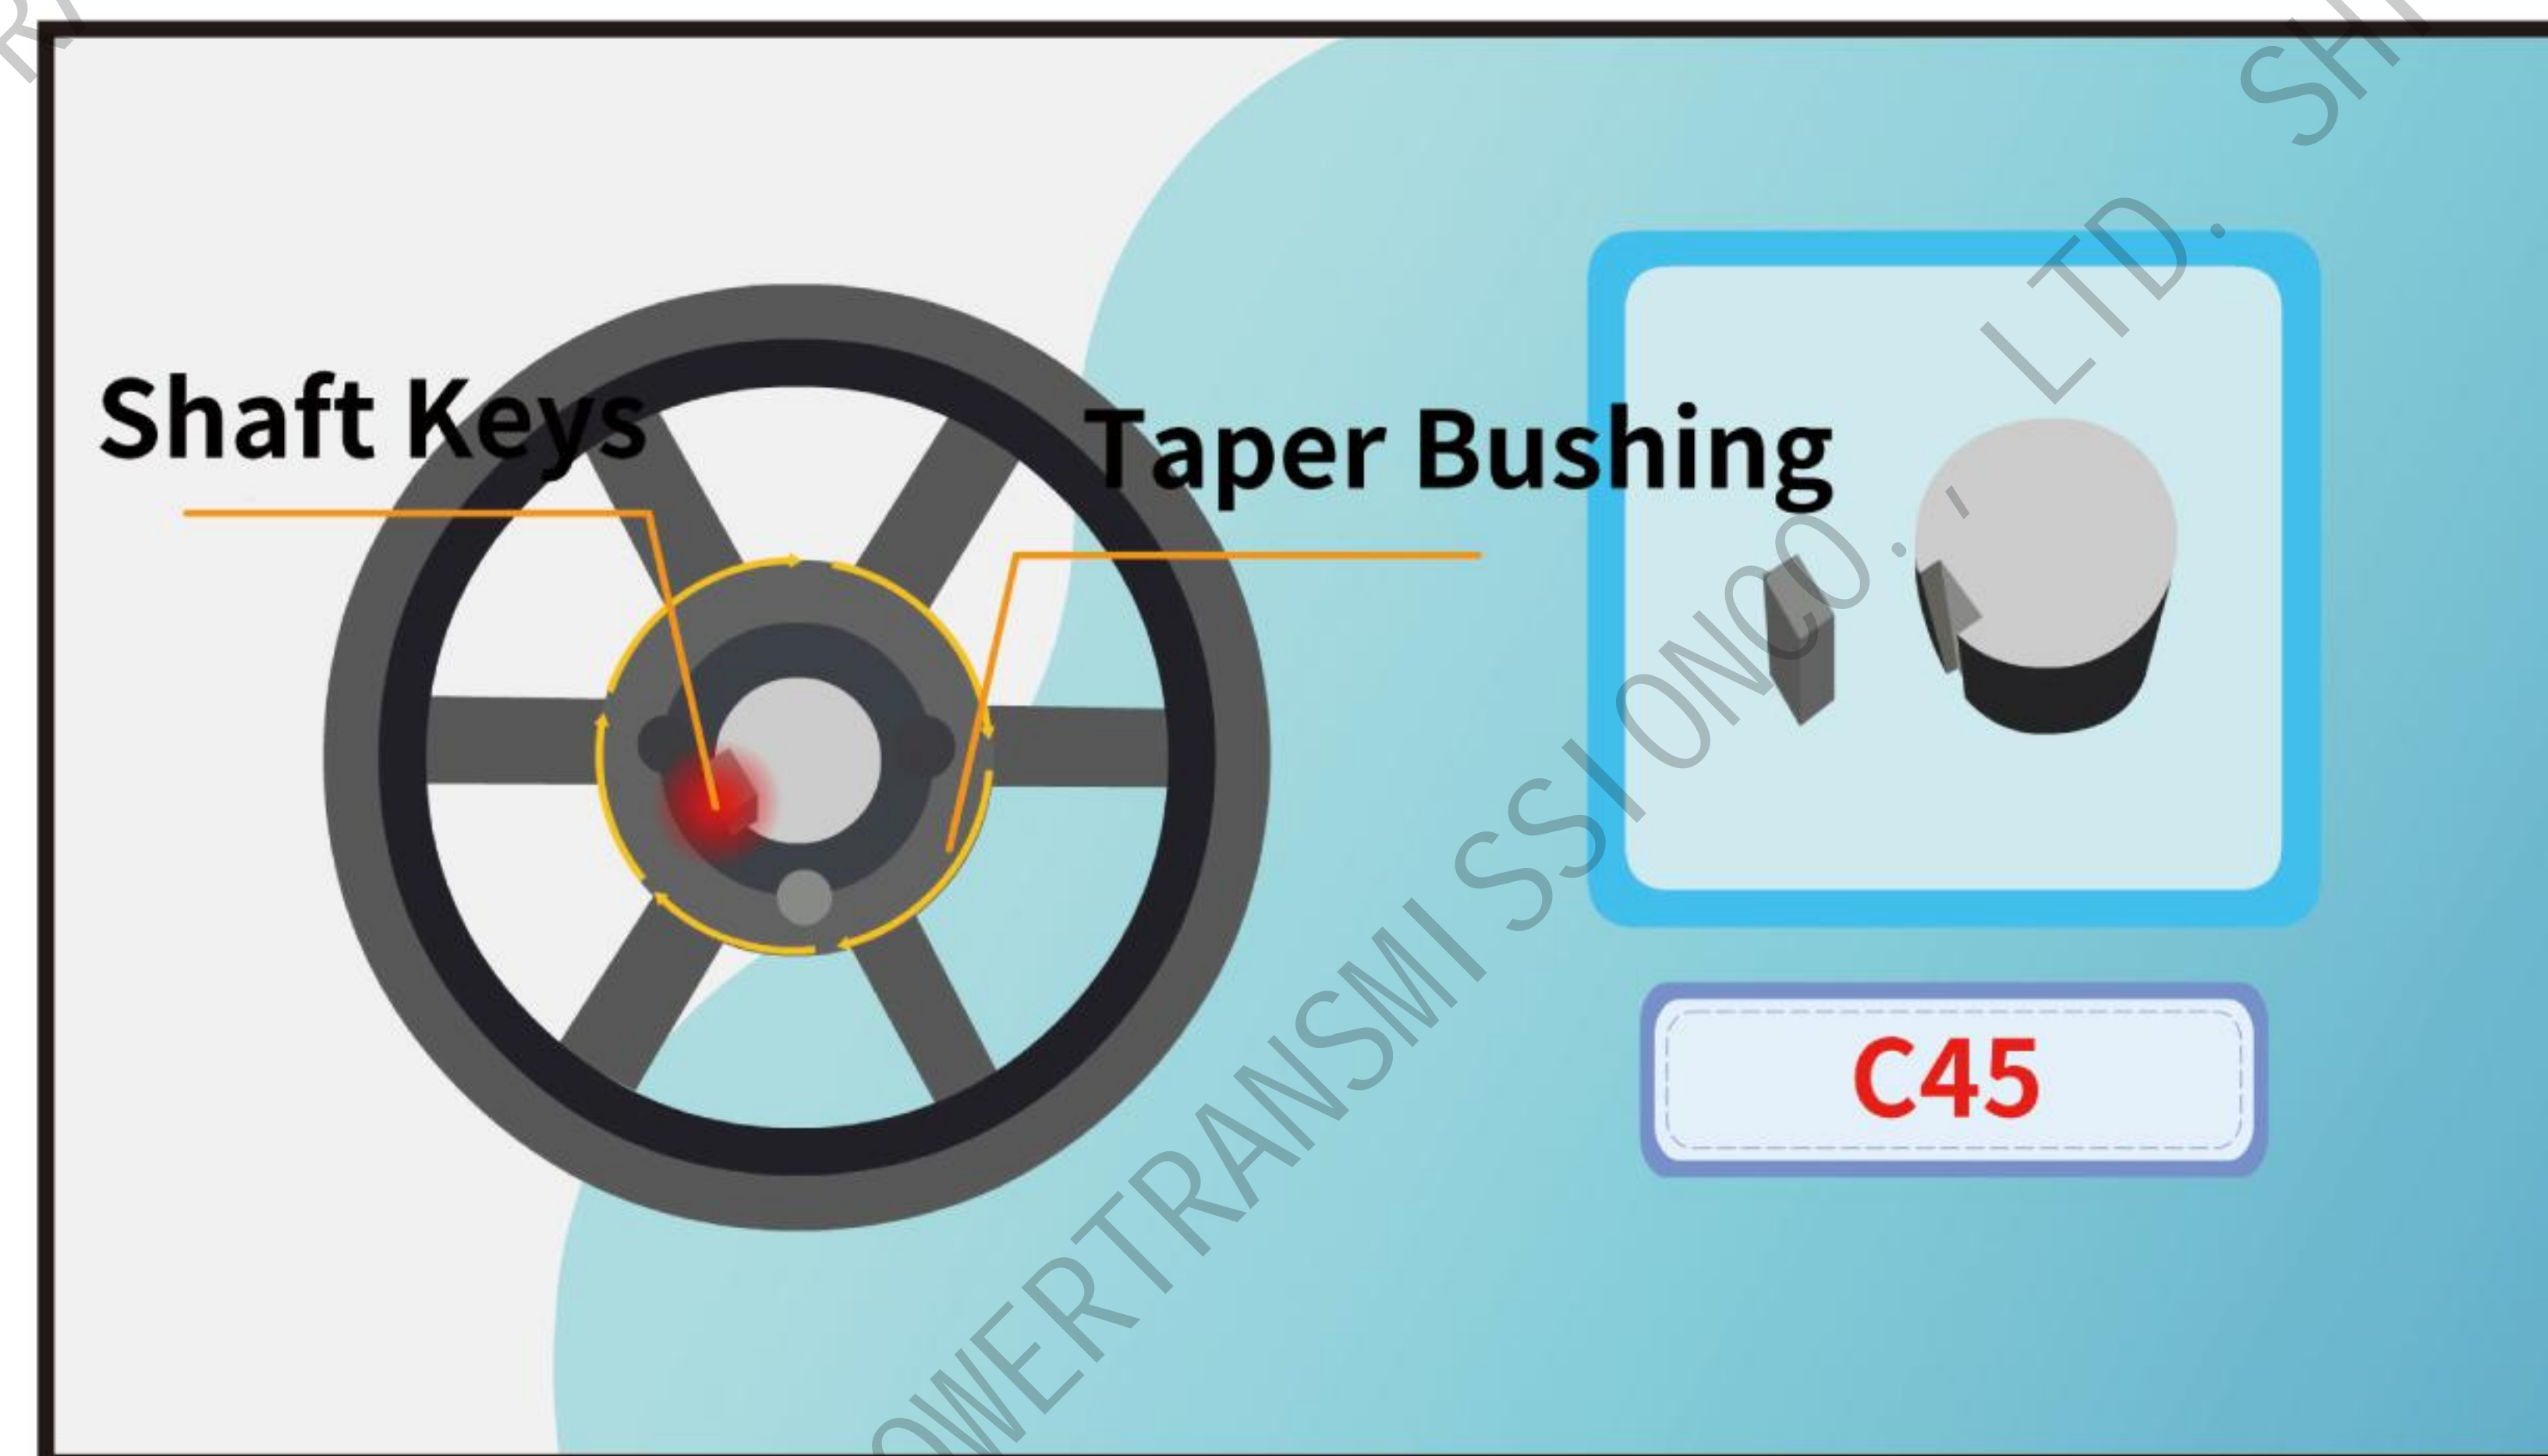
⑧ The tensile strength of C45 steel shaft keys is higher than that of cast iron bushings.

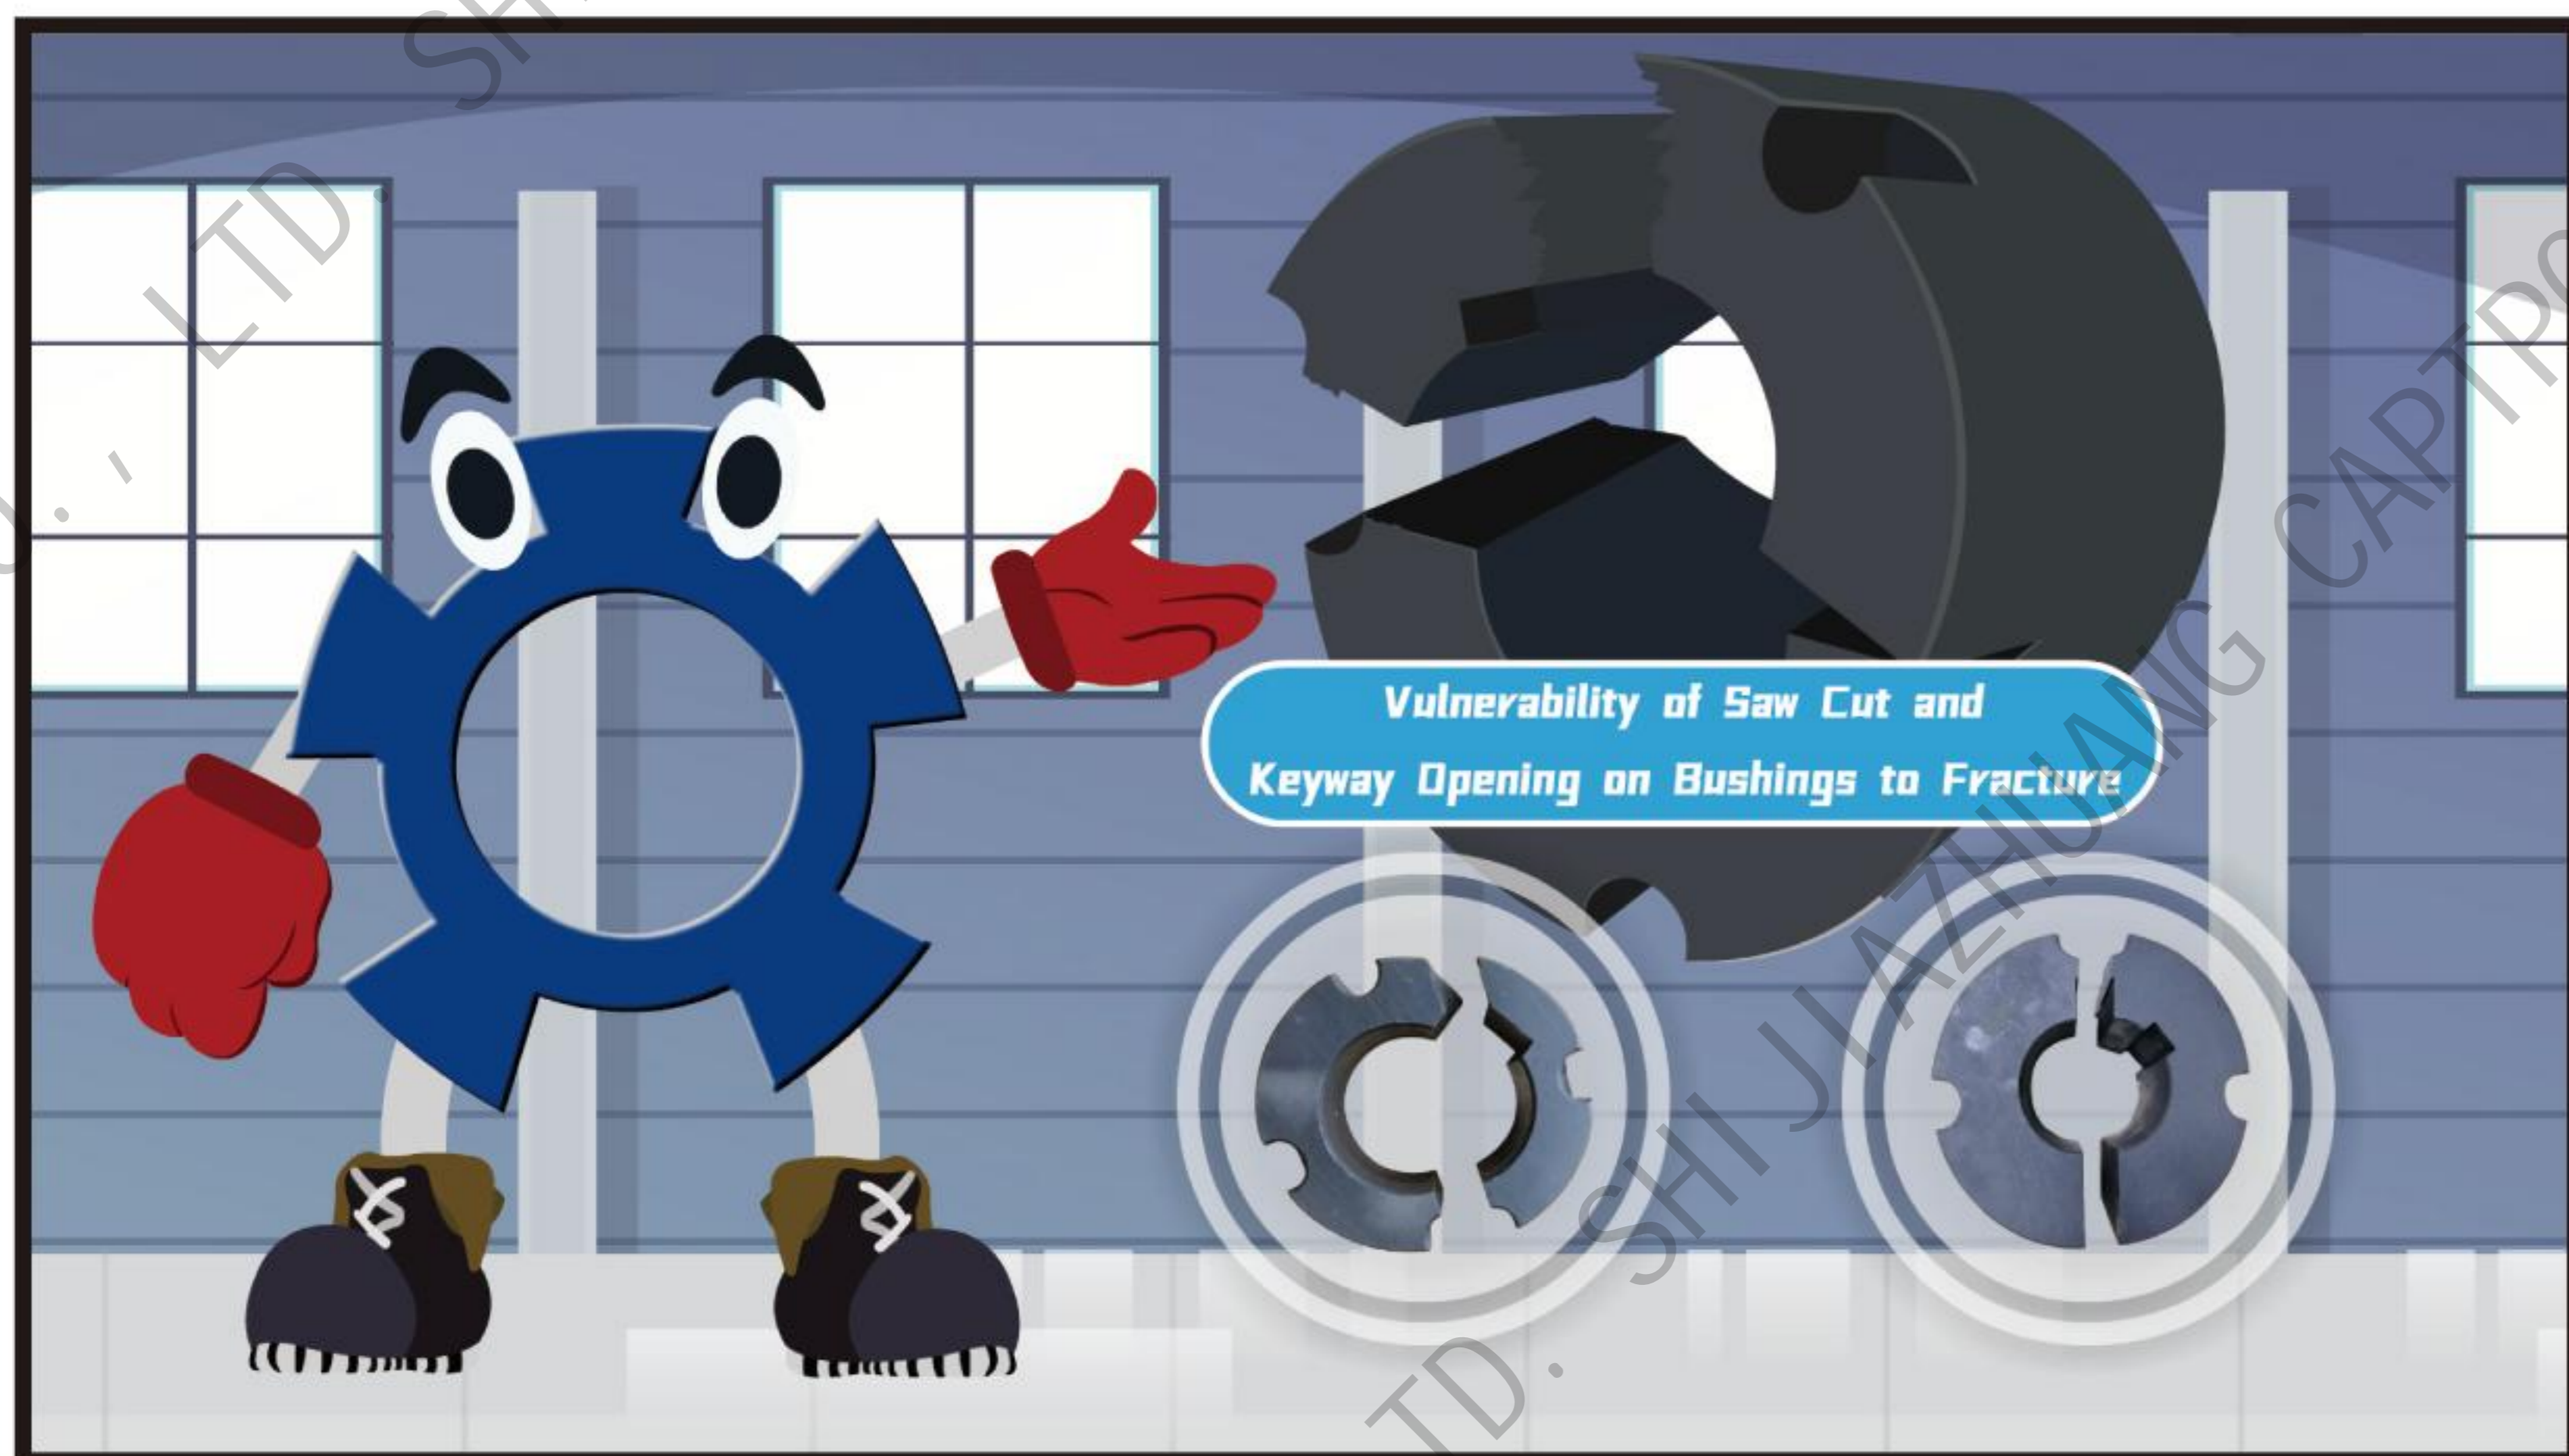
⑪ Cast iron taper bushing elastic saw cuts and key slots are susceptible to fractures.
